ULTRALIGHT AIRCRAFT AIRWORTHINESS NOTICE

AIRWORTHINESS NOTICE IDENTIFICATION NUMBER 5-99

CHINOOK AIRCRAFT – LIFT STRUT CARRY THROUGH MEMBER INSPECTION FOR CRACKING

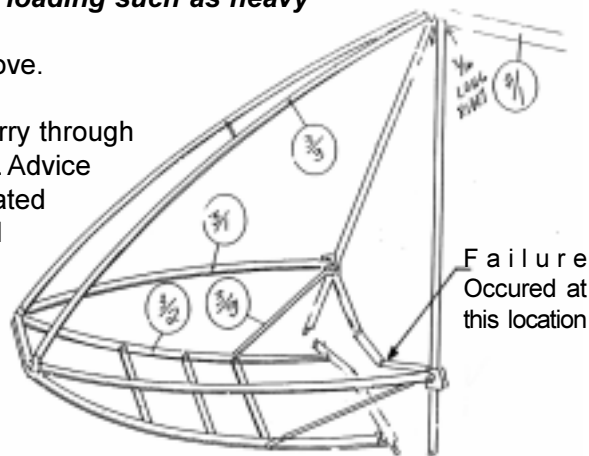
Background: A failure has been reported, thought to have been in flight, of the major structural member that passes beneath the pilot's seat connecting the two wing lift strut lower attachment points (See Attached). The failure is described as being on the left side of the member, just outboard of the bend. Initiation is suspected to have occurred on the top surface at a wrinkle caused by distortion of the member during a bending process.

1. Remove the seat to reveal the carry through member identified in the attached drawing and clean it thoroughly. Using a bright light and mirrors where necessary, carefully inspect all surfaces of the whole member for cracking and general condition paying particular attention to the areas around the bends at the seat and at the ends.
2. Any cracking will be cause for rejection and replacement of the member.

1. Repeat the actions described at 1 and 2 above.
