Australian Ultralight Federation Inc

DRIFTER MAINTENANCE ALERT – AUG 03 ENGINE MOUNT STRUCTURE – LOWER ENGINE SUPPORT BRACKETS

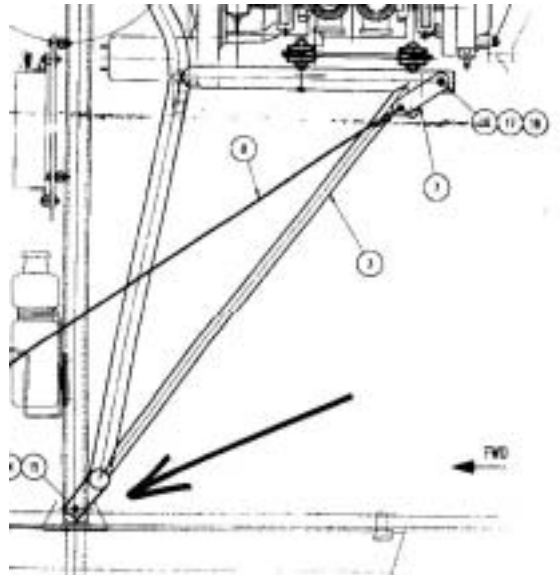
A well known Level 2 was recently required to repair a problem that the owner had found with the MTD-3D brackets which attach to the fuselage and anchor the up-tube and engine mount lower support Frame (see Diagram)

All operators of Drifters with up-right mounted engines are advised to check the whole engine mount structure of their aircraft paying particular attention to the area where the supports attach to the fuselage and to the types and condition of the “rubber” mounts.

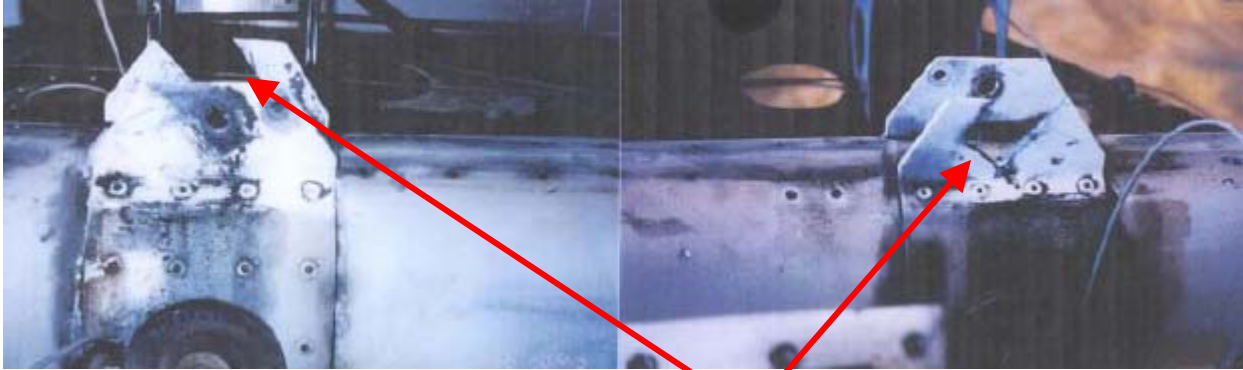
Unlike the previous problem, this current instance is caused by vibration transmitted through the lower engine mount frame which resulted in fretting so severe that it completely wore away the attachment

material of the aluminium bracket (see below)

Pictures showing fitting worn through !!!

To the knowledge of the L2 who has had vast experience with Drifter aircraft, this is the first he has seen with this type of failure in a strut braced Drifter. He states that the retaining bolt was still tight and the plastic "Top Hat" type bushing located between the bracket and the up-tube was still in place. Log book records suggest that the aircraft had operated about 300 hours with the suspect rubbers fitted.

The submitter considers the mount machined from round rod stock is too hard and this transmits vibration down the tube causing vibration distress at the tube-to-fuselage bracket. A passing comment at this stage would be that surely fretting on this scale should have been evident to the operator before such a gross wear state had been reached. For various reasons, this cannot be followed up, but the lesson is obvious.

If machined type poly mounts are fitted (machine marks are visible), fitment of replacement moulded mounts is recommended. The new Drifter factory is not officially on line yet, but a source of replacement mounts can be obtained by contacting the AUF Office.

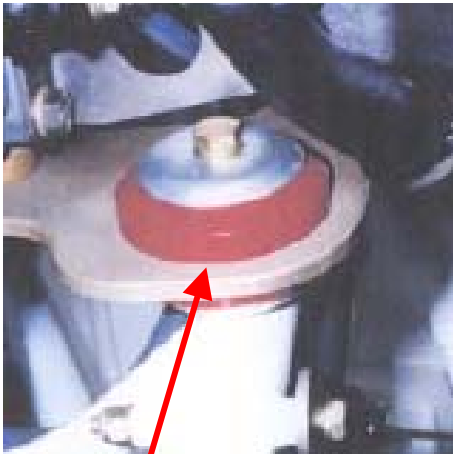
This aircraft was one of only a few that has been fitted with the Austflight polyurethane machined type engine mount rubbers. (see below)

Moulded Poly Mount

Poly Mounts should be checked regularly for integrity,

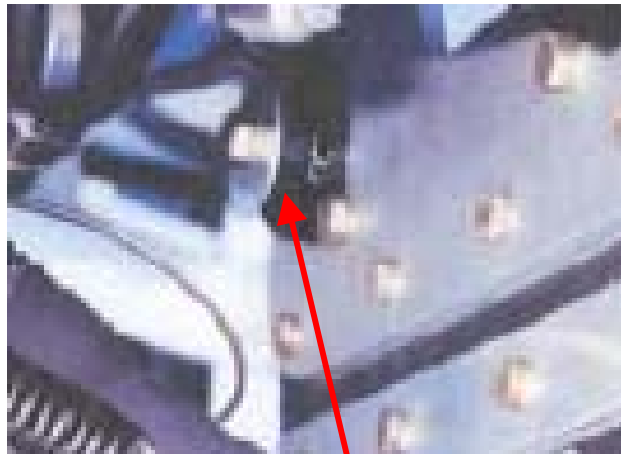
Typical Steel Neoprene (Black)
(Apologies for the clarity of the picture)
