# Australian Ultralight Federation Inc

14 August 2002

## XAIR AIRCRAFT - MAINTENANCE ALERT ELEVATOR HINGE BOLT FAILURE

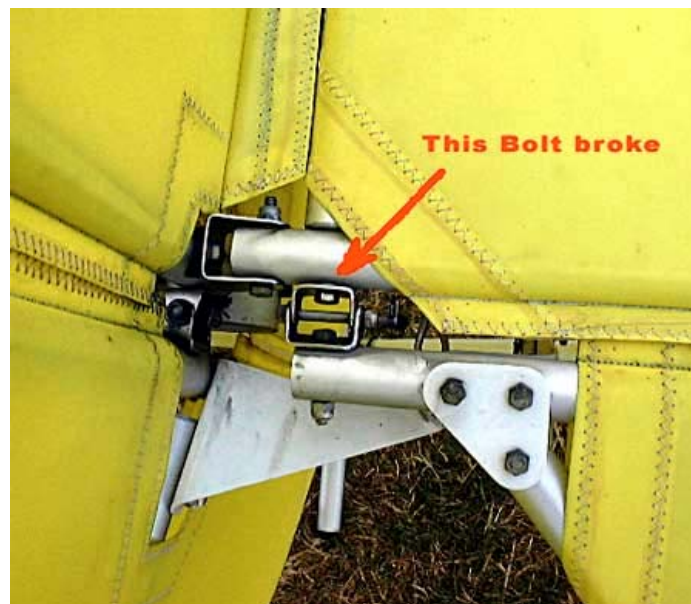
The bolt which has failed attaches the elevator hinge to the horizontal stabiliser... picture attached for clarification. The bolt broke where the thread finishes and the shaft starts.

The consequences of this bolt failure could have been serious but the pilot managed to land the aircraft about 5 miles away from the failure location without incident. Investigations are continuing into this incident and the Australian Ultralight Federation has been advised of the failure.

Several weeks prior to the failure the aircraft was involved in a major bingle with a fence on that side of the elevator, the impact was sufficient to ruin the fabric covering and deeply scratch the metal tubes which make up the elevator and horizontal stabiliser, it is our belief that this impact has damaged the bolt which went on to fail in flight.

**Action Required:** *Before next flight, at each servicing and at each instance of abnormal occurrence to the tailplane or elevator, the elevator hinge bolts of all XAIR aircraft are to be inspected for integrity. Any anomaly is cause for replacement.*

All owners are advised to inspect the hinge bolts which hold on the elevators and rudder BEFORE next flight and report back to me at <mailto:mcoates@mcp.com.au> ([info\\_tech@auf.asn.au](mailto:info_tech@auf.asn.au)) any information which they think will be helpful."
