Copy of  
**SKYFOX AVIATION**  
**SERVICE BULLETIN No 12**

**THROTTLE CONTROL**

**Aircraft Type:** - CA 22 / CA 25 SKYFOX  
- CA 25N GAZELLE

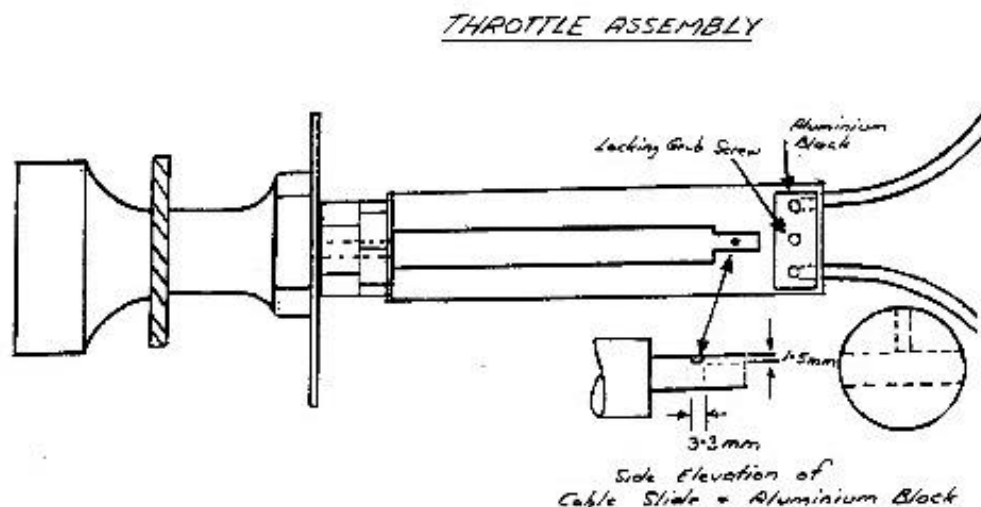
FIGURE 1

An incident occurred whereby the throttle retaining grub screw worked loose causing the throttle to disengage from its housing.

The rectification of the problem will be to make a small recess into the centre of the cable slide which inserts into the aluminium block.

This can be performed by using a 1/8" drill bit and drilling only into the depth of the point of the drill (approx 1.5mm)

This recess will ensure the grub screw has a definite locating position.

Remove centre grub screw from aluminium block located in throttle assembly.

Remove throttle grub screw.

Carry out drilling of a small recess in throttle control slide.

Refit throttle control aligning recess with grub screw hole

Fit grub screw using loctite thread sealant.

Operate throttle to full range ensuring both open and closed stops are reached on carburettors.
