# Australian Ultralight Federation Inc

15 May 2001  
13 June 2001

## MAINTENANCE ALERT: GSC PROP - TOWNSVILLE ACCIDENT

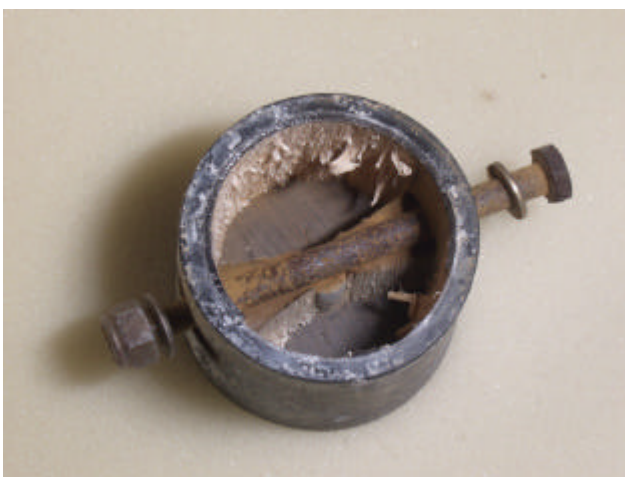
Photograph No 1

In the case in question, the through bolt was very badly corroded and the material of the blade was badly discoloured suggesting that the moisture which caused the corrosion had also commenced to reduce the integrity of the wooden blade material itself (it was apparently going rotten!).

The first at Figure 1 is a good illustration of how the wooden root has just pulled out of the socket leaving the fibres which had been penetrated by the glue in place still glued to the socket.

Operators of these propellers are advised to assess whether the propellers should be disassembled for inspection. One obvious indicator would be to remove the through bolts to check their surface condition. However, if these bolts have been replaced during the life of a propeller, they may be in good condition yet the material of the blades which would have been subject to the environment for the full life of the blades may not necessarily be the same.

Signs of advanced problems may be evident where the blade exits the plastic socket but it would be necessary to disassemble the propeller to be really sure.

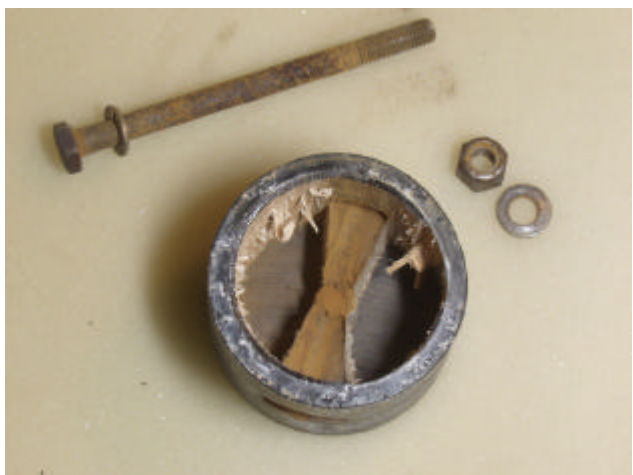
Photograph No 2

The second at Figure 2 clearly shows the rusty bolt and the plug of deteriorated wood it prevented from pulling out and it shows another view of the surface wood of the blade glued to the inside of the socket. The only value of the bolt in the case of a faulty blade root is to prevent the socket from departing with the blade: no use at all if the rest of the blade is faulty. It doesn't matter how good the glue is or how secure the bolt is - if the wood is faulty, the blade will separate.
