Number: SB-100-01-01  
Issued: 28-11-2011

**SUBJECT:** Service Alert – applicability of ASB-912-059UL  
»Checking of the Crankshaft Journal (Power Take Off Side)«

## CHECKING OF THE CRANKSHAFT JOURNAL (POWER TAKE OFF SIDE) FOR ROTAX® ENGINE TYPE 912 AND 914 (SERIES)

ASB-912-059UL

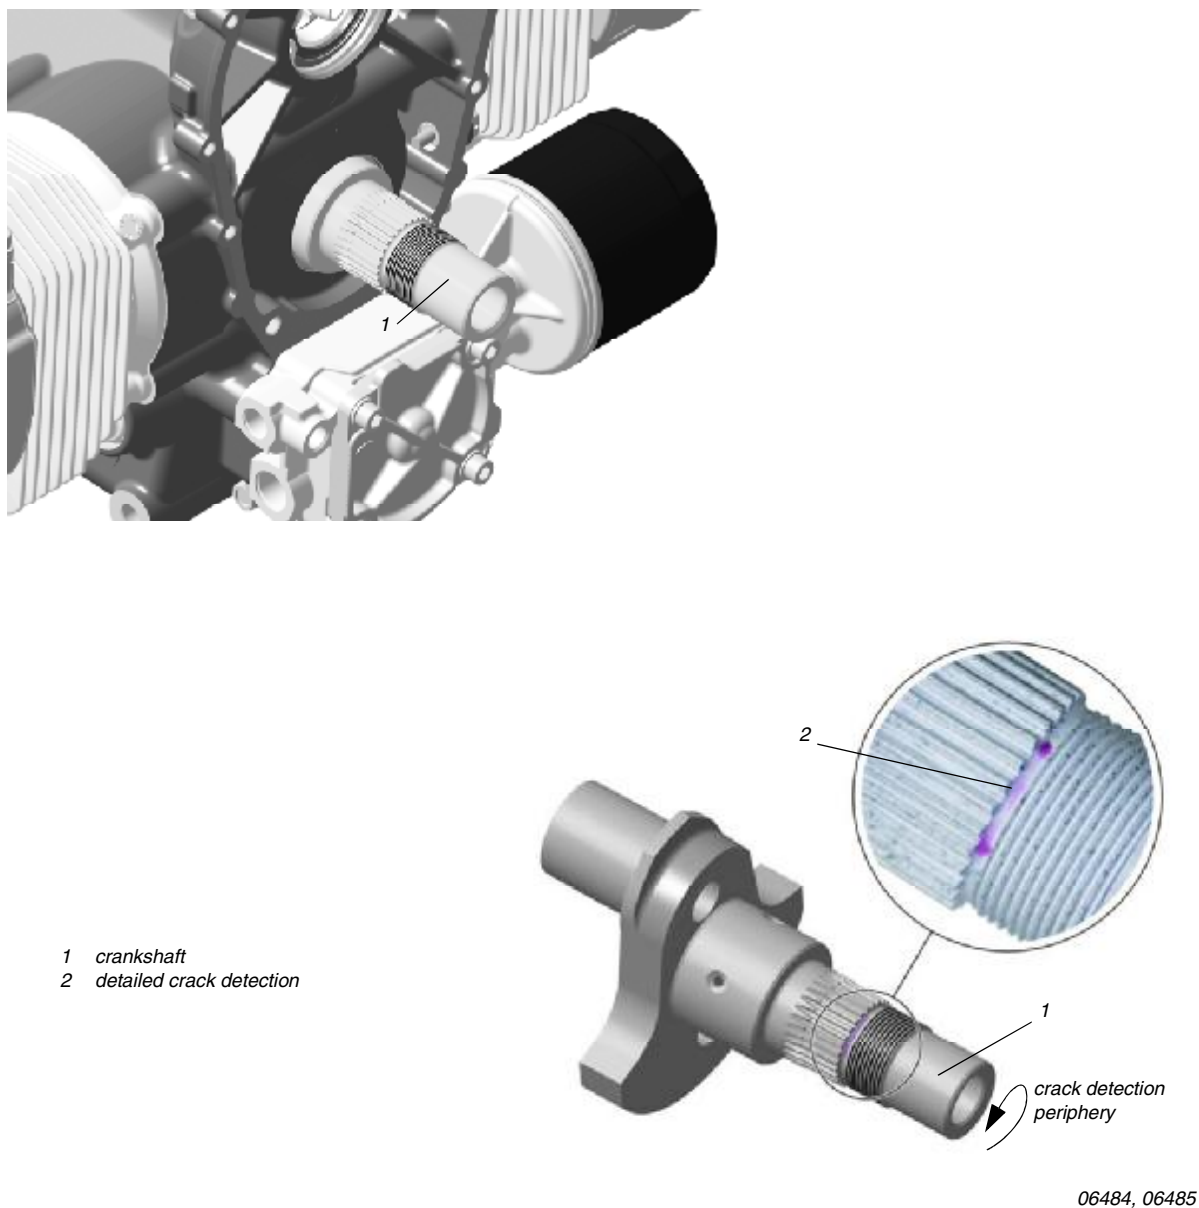
**Fig. 1**  
**crankshaft journal**

Due to a deviation in the manufacturing process some crankshafts may have a crack formation occur on the power take off side. These cracks can cause a breakage of the crankshaft support bearing and may lead to engine stoppage.

- Detailed crack detection in the area (2) of the thread runout using penetration test. Perform this test in accordance to the requirements of the applicable aviation authority in your region for non destructive testing (NDT) and according to DIN EN 571 or equivalent.

- ◆ NOTE: Protect the crankcase against contamination by the test material.
    - CAUTION: In case of crack or doubt contact your aircraft manufacturer and your nearest authorized ROTAX aircraft engine distributor. The engine must not be taken into operation until the cause has been identified and eliminated.

7. If no cracks can be found, then the reassembly has to be conducted in accordance with following steps:
    - Lock the crankshaft in accordance with the relevant Maintenance Manual (Line).
