RECREATIONAL AVIATION AUSTRALIA INC

ULTRALIGHT AIRCRAFT AIRWORTHINESS NOTICE

AIRWORTHINESS NOTICE IDENTIFICATION NUMBER : 250706-1

ICP SRL Savannah and Bingo

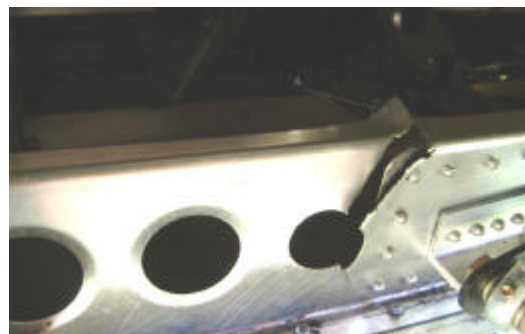
Reason: An aircraft was found to have significant cracking of the rear cross member that provides support for the flying controls. If uncorrected this could lead to ineffectiveness of flying controls and consequent loss of the aircraft.

As you can see, at point marked "A" a kink has been made during installation, probably this item was installed too late during the assembly, so that it was necessary to push it inside the fuselage in order to put it in place. From this point a crack has developed. This is a very visible place to inspect by opening the bottom fuselage inspection panel."

Further Action: This inspection is required as an ongoing basis and must be complied with at least every 100 hours or twelve months, whichever comes first. Incorporation into the daily inspection of the aircraft is recommended. Ensure that there is no deformation or kinks in the cross member which could lead to a failure (point A).
