### ULTRALIGHT AIRCRAFT AD NOTICE

#### ALL SKYFOX AND GAZELLE AIRCRAFT- AILERON ROD END FAILURE

### SERVICE BULLETIN NO. 21

#### AILERON CONTROL SYSTEM SECURITY - MOD. 12/97

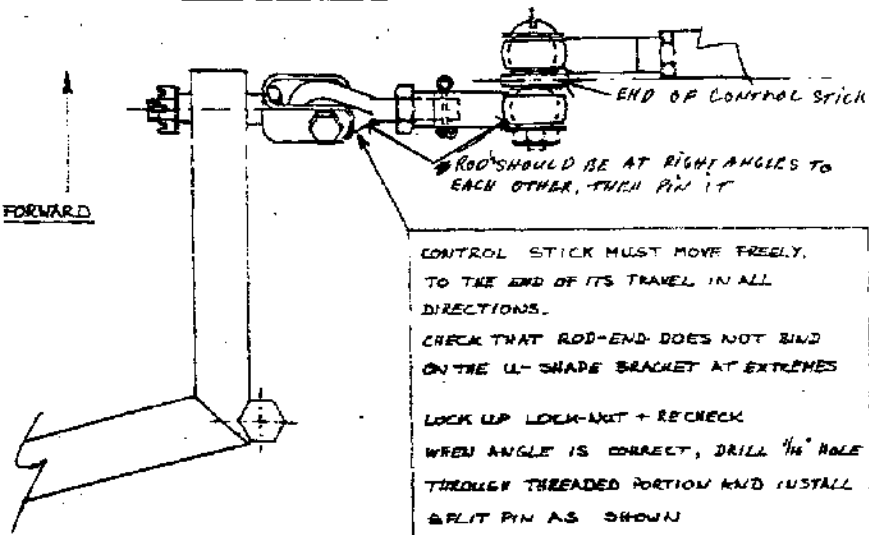
VIEWED FROM ABOVE

Control stick must move freely, to the end of its travel in all directions. Check that rod end does not bind on the u-shape bracket at extremes. Lock up lock nut and recheck, when angle is correct, see the drawing on Page 2, drill 1/16" hole through threaded portion and install split pin as shown.
