**PRELIMINARY REPORT ON INSPECTION OF FAILED MAIN CARRY-THROUGH MEMBER -**

**SKYFOX CA 22 S/n CR22 034 Registration 55-757**

This aircraft was inspected on 9/8/95 at Custom Aero Services, Toowoomba (Phone 076 331 833; Fax 076 331 833).

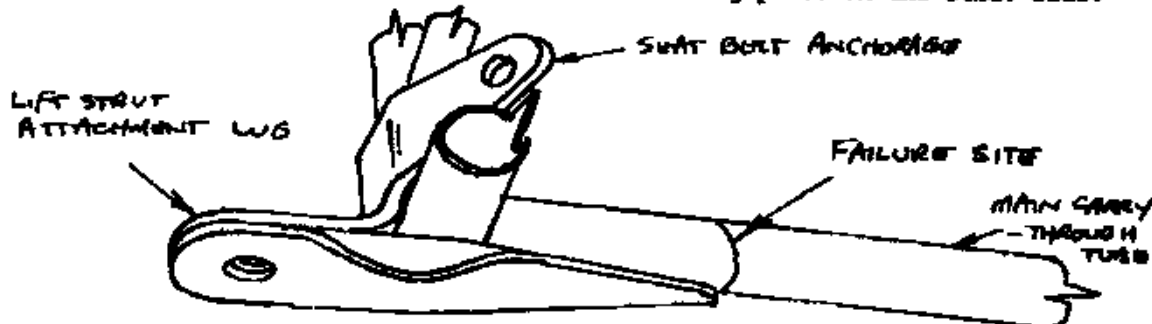
The main tension carry-through member that connects the lift struts had failed in tension at the inboard end of the lift strut lug plate on the stbd. side.

The failure occurred during flight; the lower longeron and other members at the adjacent cluster had managed to carry the load, thus preventing loss of the wing, although gross deformation occurred. This aircraft had previously been repaired following a landing accident, and the lower longeron from the lift strut cluster forward, had been replaced with 0.058 inch wall material; this had bent plastically, but had not buckled, and was clearly a major factor in preventing loss of the wing.

The carry-through tube (which appeared to be 3/4 inch x .035 inch tube) was severely corroded internally. A piece cut from the tube, approximately six inches long, appeared to be fairly uniformly corroded over its full length.

The fracture face showed that the final failure took place through about 16% of the circumference, located at the top of the member; the final fracture zone showed characteristic necking and ductile slip faces. The remaining 84% or so of the circumference was quite corroded, showing that it had been cracked for some time. However, it could be seen that the fracture surface was substantially normal to the thickness of the tube, and no local reduction of area was evident. This is consistent with a fatigue failure. The fracture faces were too corroded to detect striations.

1. All CA 21 and CA 22 aircraft be inspected in this area.

In the case of aircraft more than one year old, or where any weld repair has been carried out in this vicinity, this should be done before further flight.

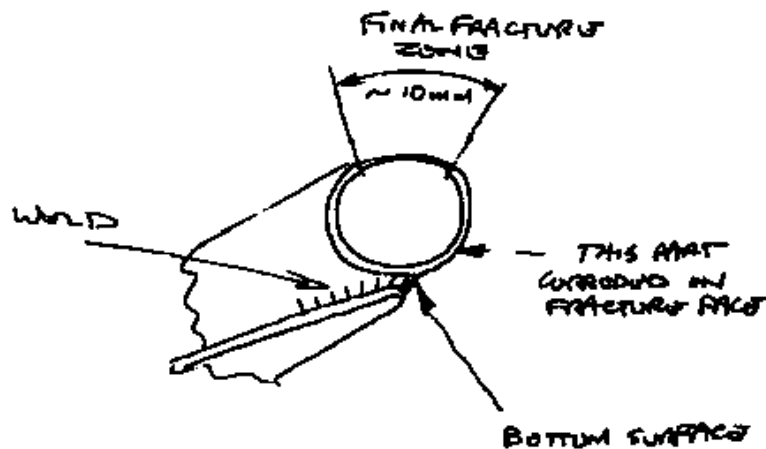
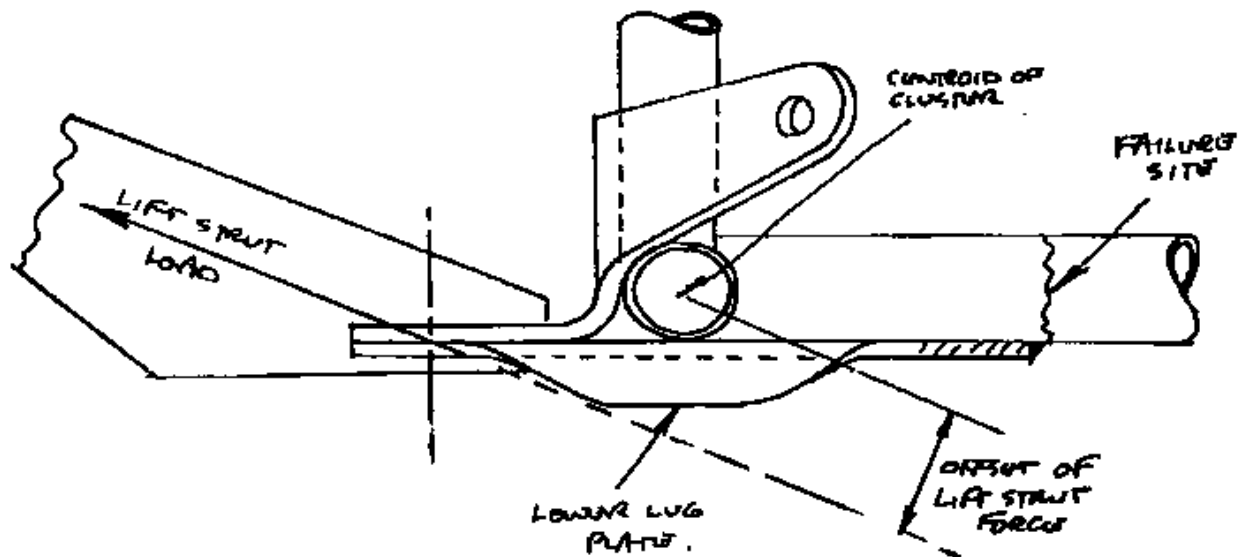
The failure had occurred precisely where one would expect a fatigue failure to occur, namely at the end of a weld, where there was a combination of bending and tensile stress:

(Because of the lug geometry used to allow folding of the wings, there is a substantial offset of the lift-strut load, thus generating a large moment about the adjacent cluster. As the carry-through member is the largest size tube at this cluster, it will react a major part of this moment, in addition to the tensile carry-through load. These produce additive tensile loadings at the bottom of the carry-through member, and the local stress is concentrated adjacent to the inner end of the lower lug plate).

Whilst the issue is clouded by the history of a repair that may have burned-out the internal corrosion inhibitor, this site is an obvious candidate for a fatigue failure under the prevailing loads, and the possibility exists that the corrosion was a secondary factor.
