Australian Ultralight Federation Inc

9 November 2001

Alert - Warp Drive Propellers - Power Absorption Capacity

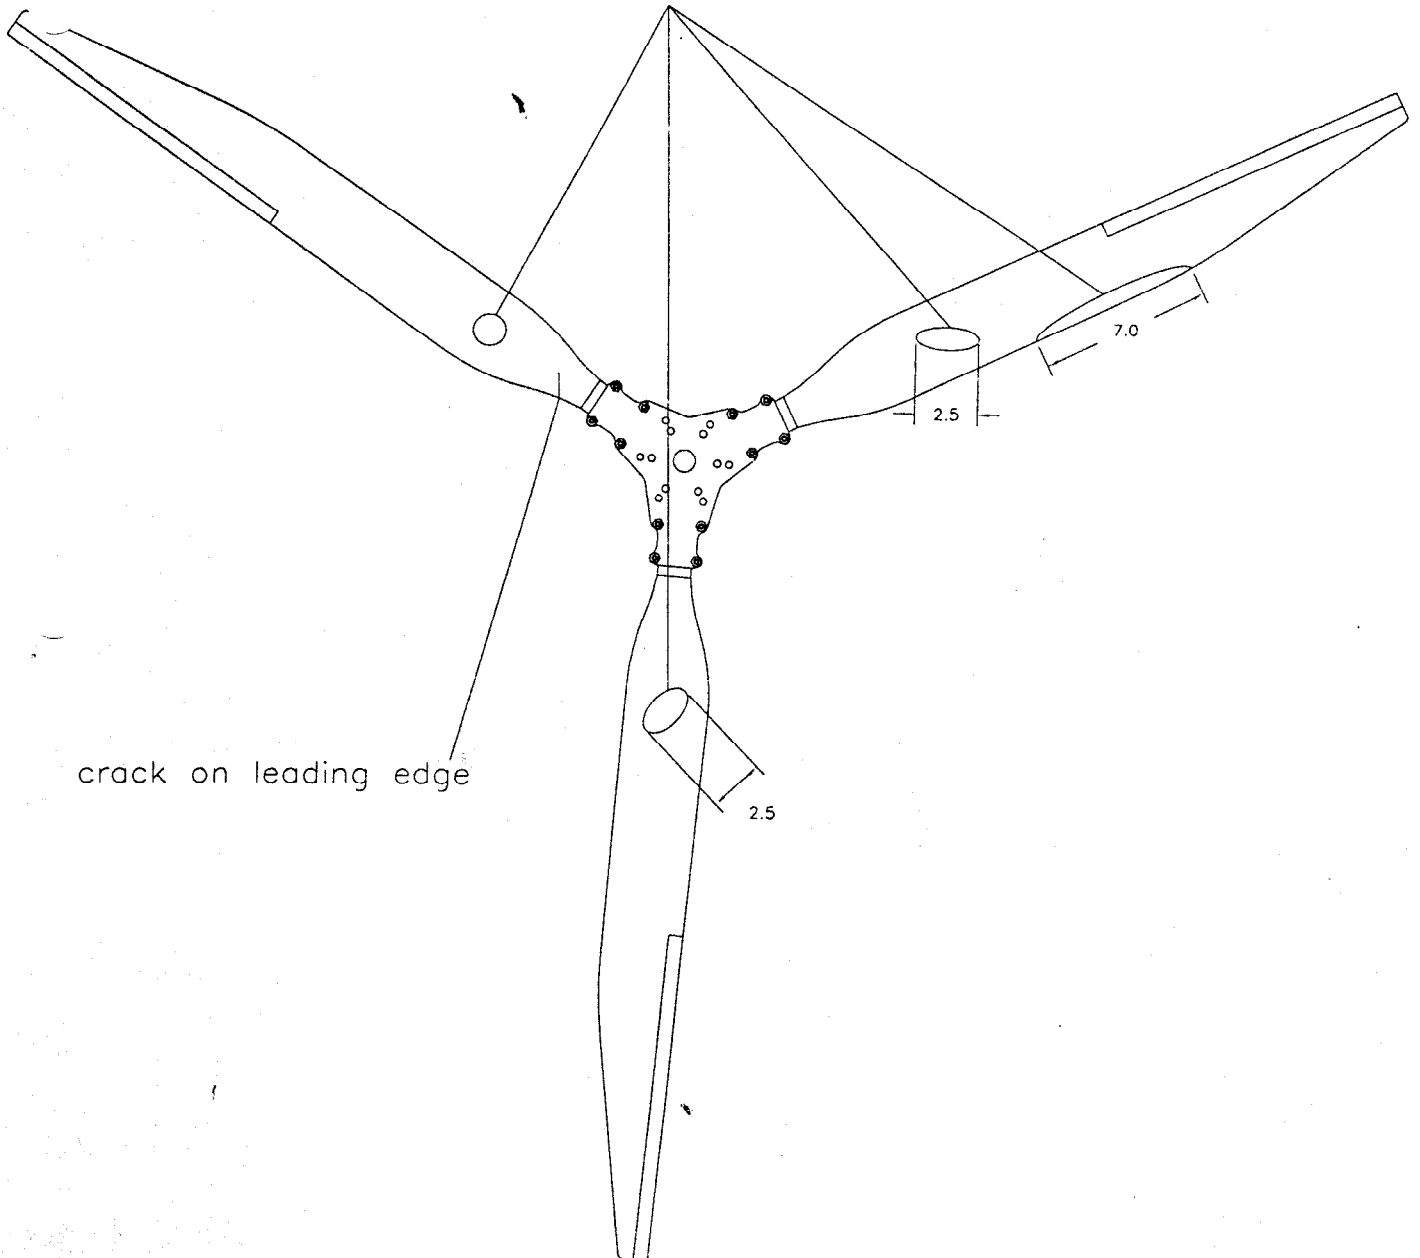
Areas of delaminating found on our factory demonstrator

3 blade 72" dia. tapered
on RANS S-16 factory AC
with 200 hrs. since new.
Engine Continental IO-240
(125 HP)

Pitch
13.2deg.
on tip

areas of delaminating

crack on leading edge

- Anyone operating an aircraft with a two bladed Warp Drive propeller driven by an engine capable of delivering more than 100HP should cease using it and change the propeller type.
- Anyone using a three bladed Warp Drive propeller on an engine capable of 100HP or more (not only Rotax) should perform a thorough inspection of the hub and blades at least every 25 hours
