RECREATIONAL AVIATION AUSTRALIA INC

AIRCRAFT AIRWORTHINESS NOTICE

AIRWORTHINESS NOTICE IDENTIFICATION NUMBER : 041207-1

X-Air HANUMAN

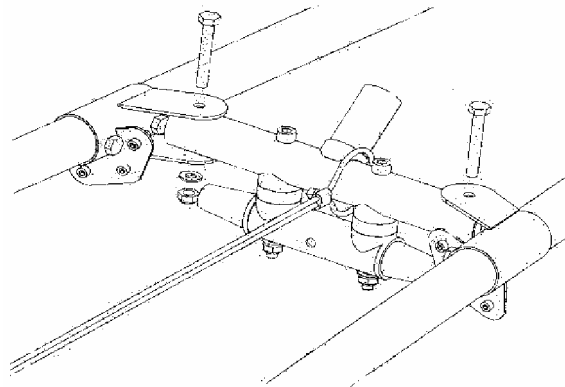
BEFORE

Discussion: The previous attachment of the shoulder harness to the cross tube which connects the vertical stabiliser is considered to be less effective than the current design, attaching the shoulder harnesses to the longeron / cross tube joint via separate securing tangs for each harness.

Compliance: Before next flight, owners of X-Air Hanuman's are to check that the shoulder harness is attached in a manner conducive to the latest assembly manual available from the Rand-Kar website or their associated distributor's websites. Register compliance with AN 041207-1 in the aircraft log book.
