Zlin Aviation s.r.o.

CAUTION

Savage maintenance

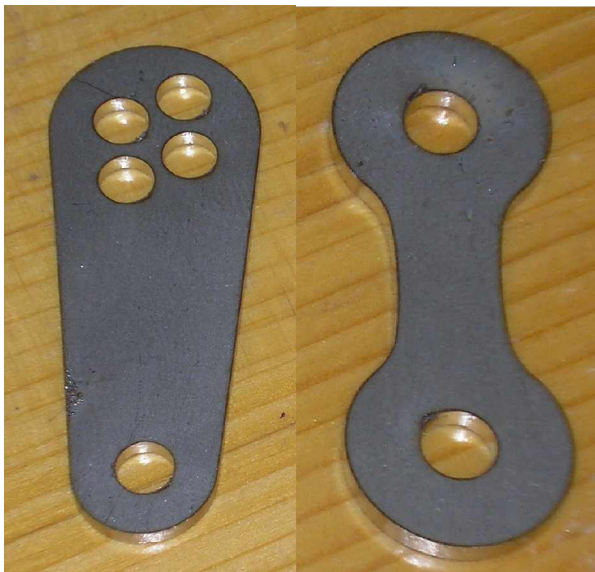
- **Airplanes affected**
Savage, all Models and Serial numbers
- **Reason**
Addition to the maintenance manual.
- **Subject**
Visually check all stainless steel tail plates (16 pieces) for the fixation of the cable on the horizontal stabilizer.

12 pieces

4 pieces

- **Compliance**
Date of Issue of technical advice.
- **Accomplishment**
Every year during annually check or every 50 hours of operation, whichever occurs first, you must make a visually check of all steel tail plates (16).
Visually check for cracks in the area of the holes and in the bending zone.
Too little tension in the steel wiring for the horizontal stabilizer creates little vibrations that could harm the steel plates. Make sure the cable have the right tension. If in doubt, call your dealer for further assistance.
Note this check in your maintenance manual. If you are not able to check and comply personally, ask us or a technician for further assistance.
If there are not anomalies found regarding those parts the plane is airworthy.
It is only an addiction to the maintenance manual, there is no Savage model affected by this problem
